ABERDEEN AIRPORT

This report describes how your pavement maintenance management program was developed. This program was developed as part of the Network Pavement Management Program project sponsored by the Idaho Transportation Department, Division of Aeronautics. The information and data contained in this report ensures you are in compliance with the requirements of Federal Aviation Administration (FAA) Grant Assurance Number 11 which states that any airport requesting federal funds for pavement improvement projects must have implemented a pavement maintenance management program (PMMP).

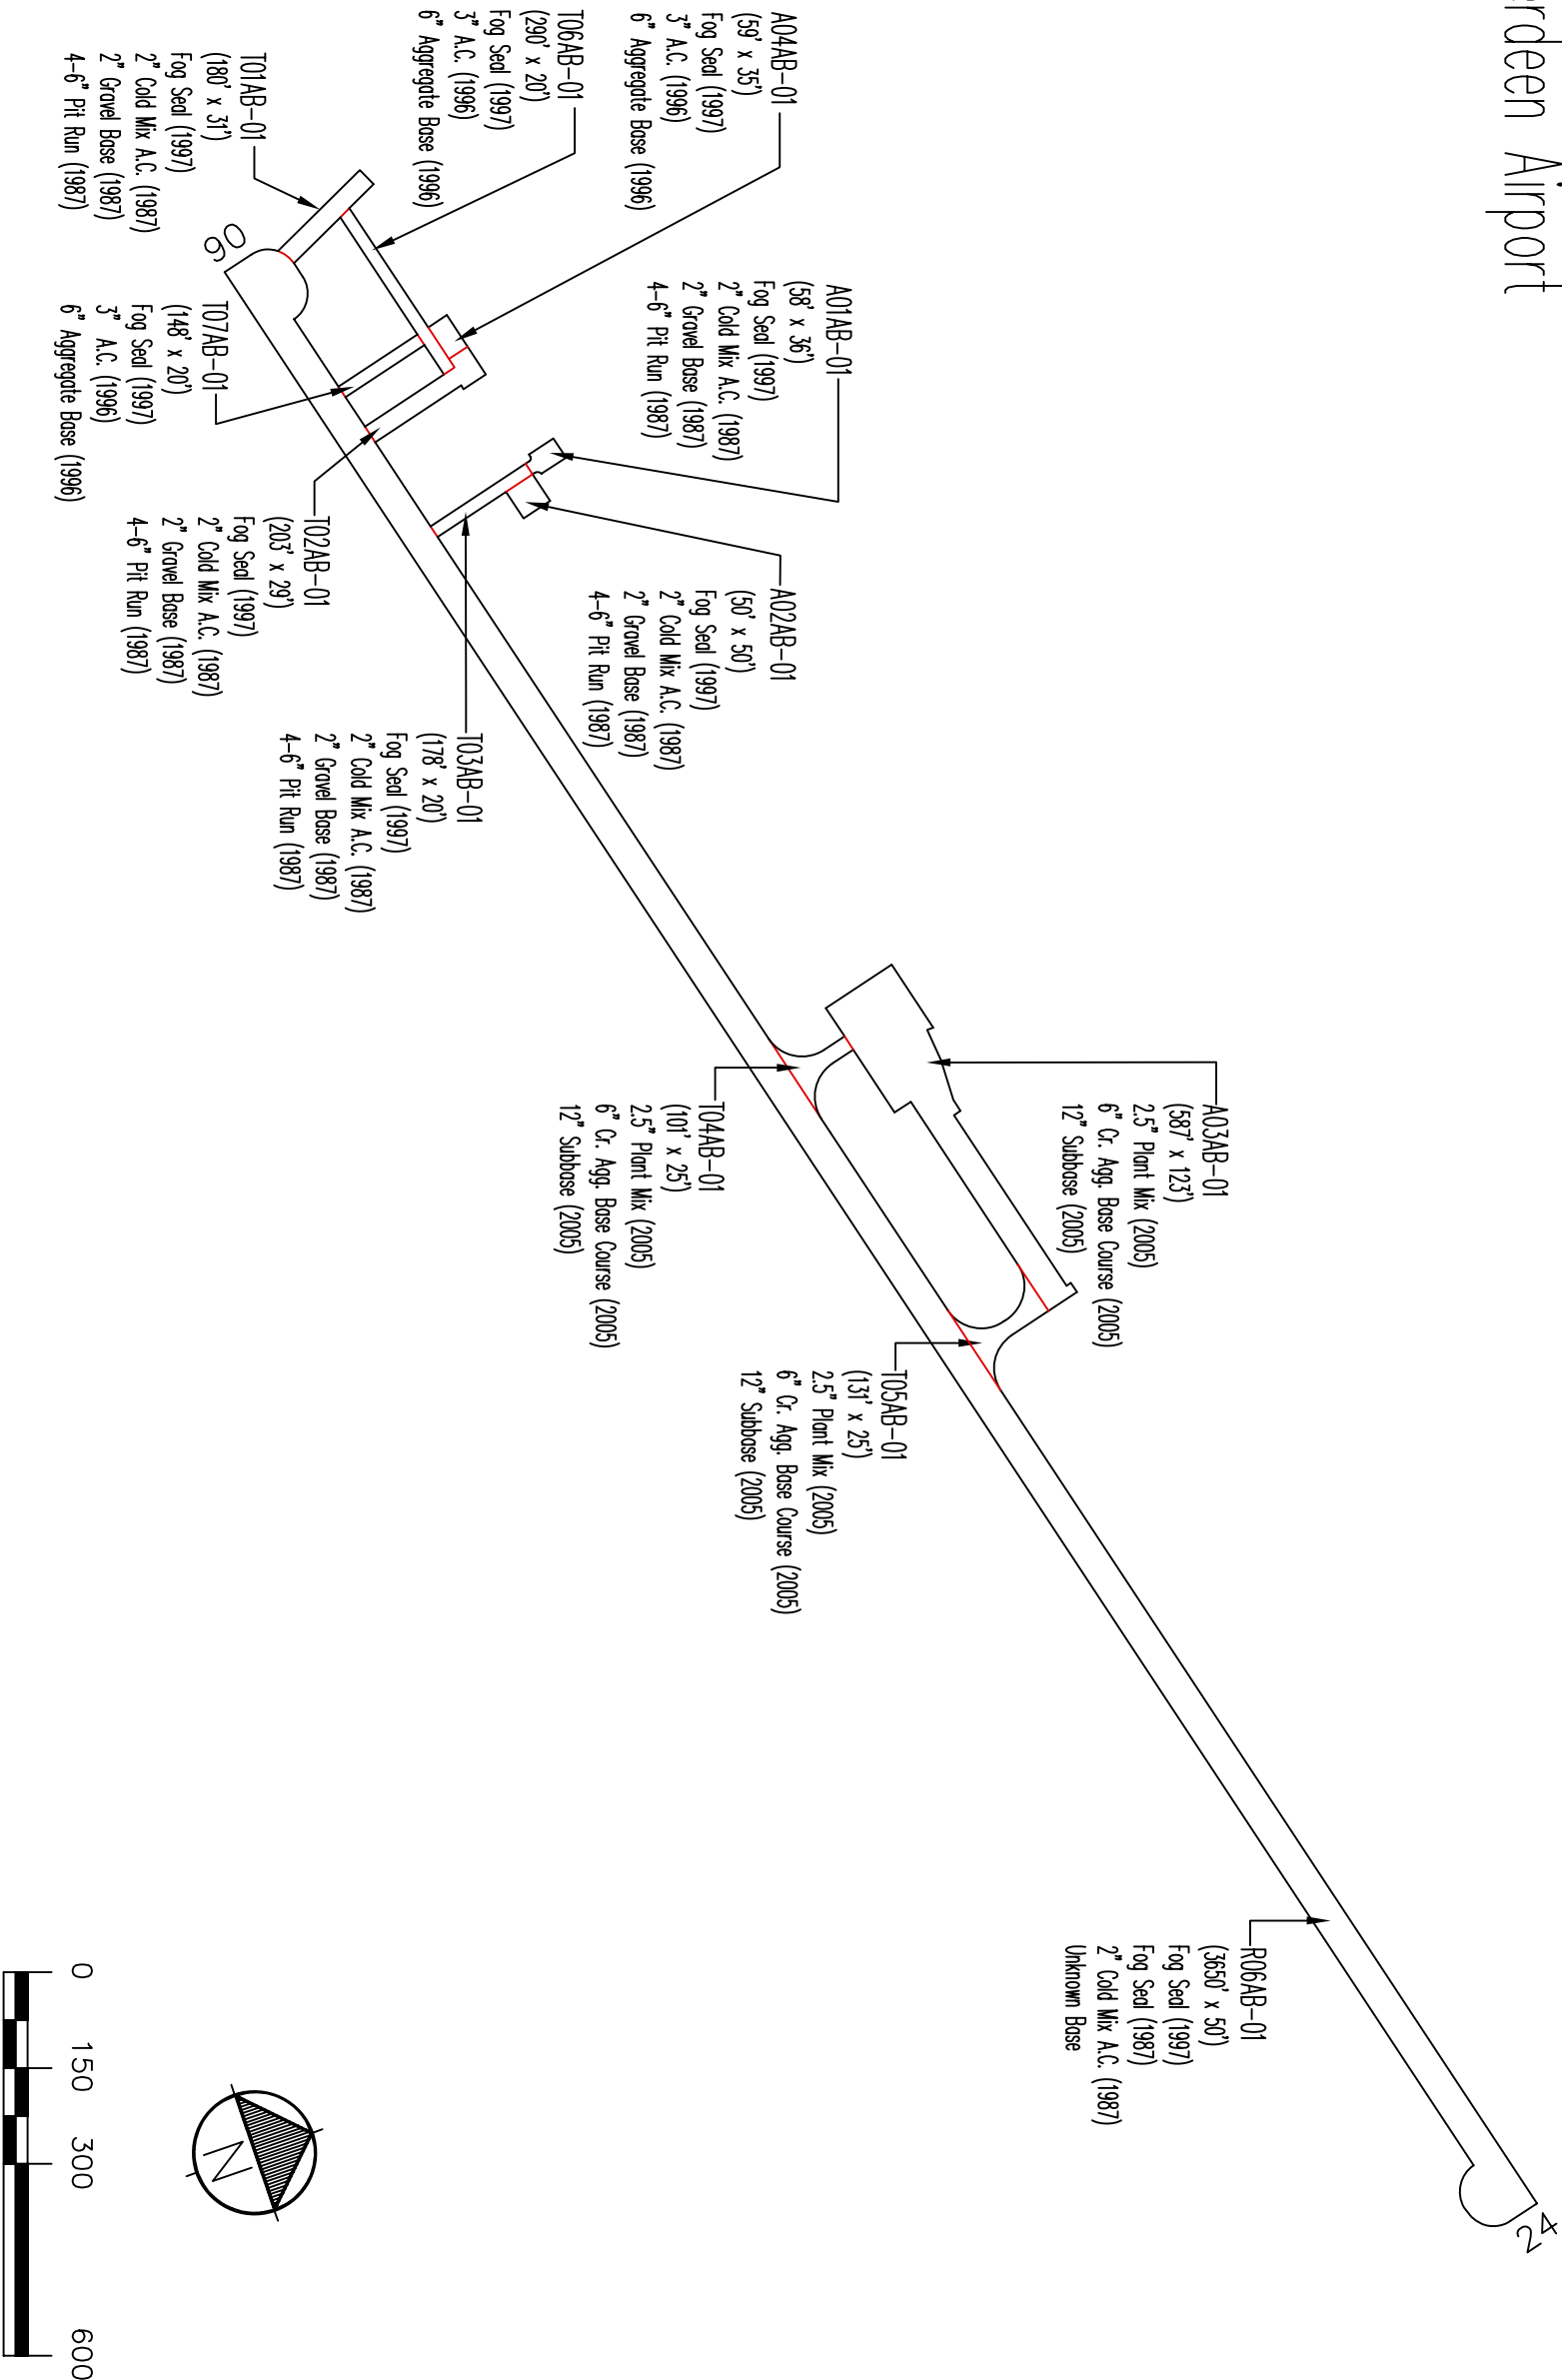
Figure AB-1. Airport Layout, Pavement and Dimensions Cross-Section.
Aberdeen Airport

To determine how your pavements were constructed and their age, a records review was conducted. Figure AB-1 shows the records review results. This figure shows pavement boundaries, dimensions, pavement layer types, thicknesses and dates of construction. Table AB-1, provided in Appendix 1, contains the up-to-date cross-section information for each pavement section. The most recent construction date for each pavement can also be found in the Section Condition Report in Appendix 2. Figure AB-1, Table AB-1, and the information contained in Appendices 1 and 2 ensure that your airport complies with the “pavement inventory” requirement of FAA’s PMMP guidelines.

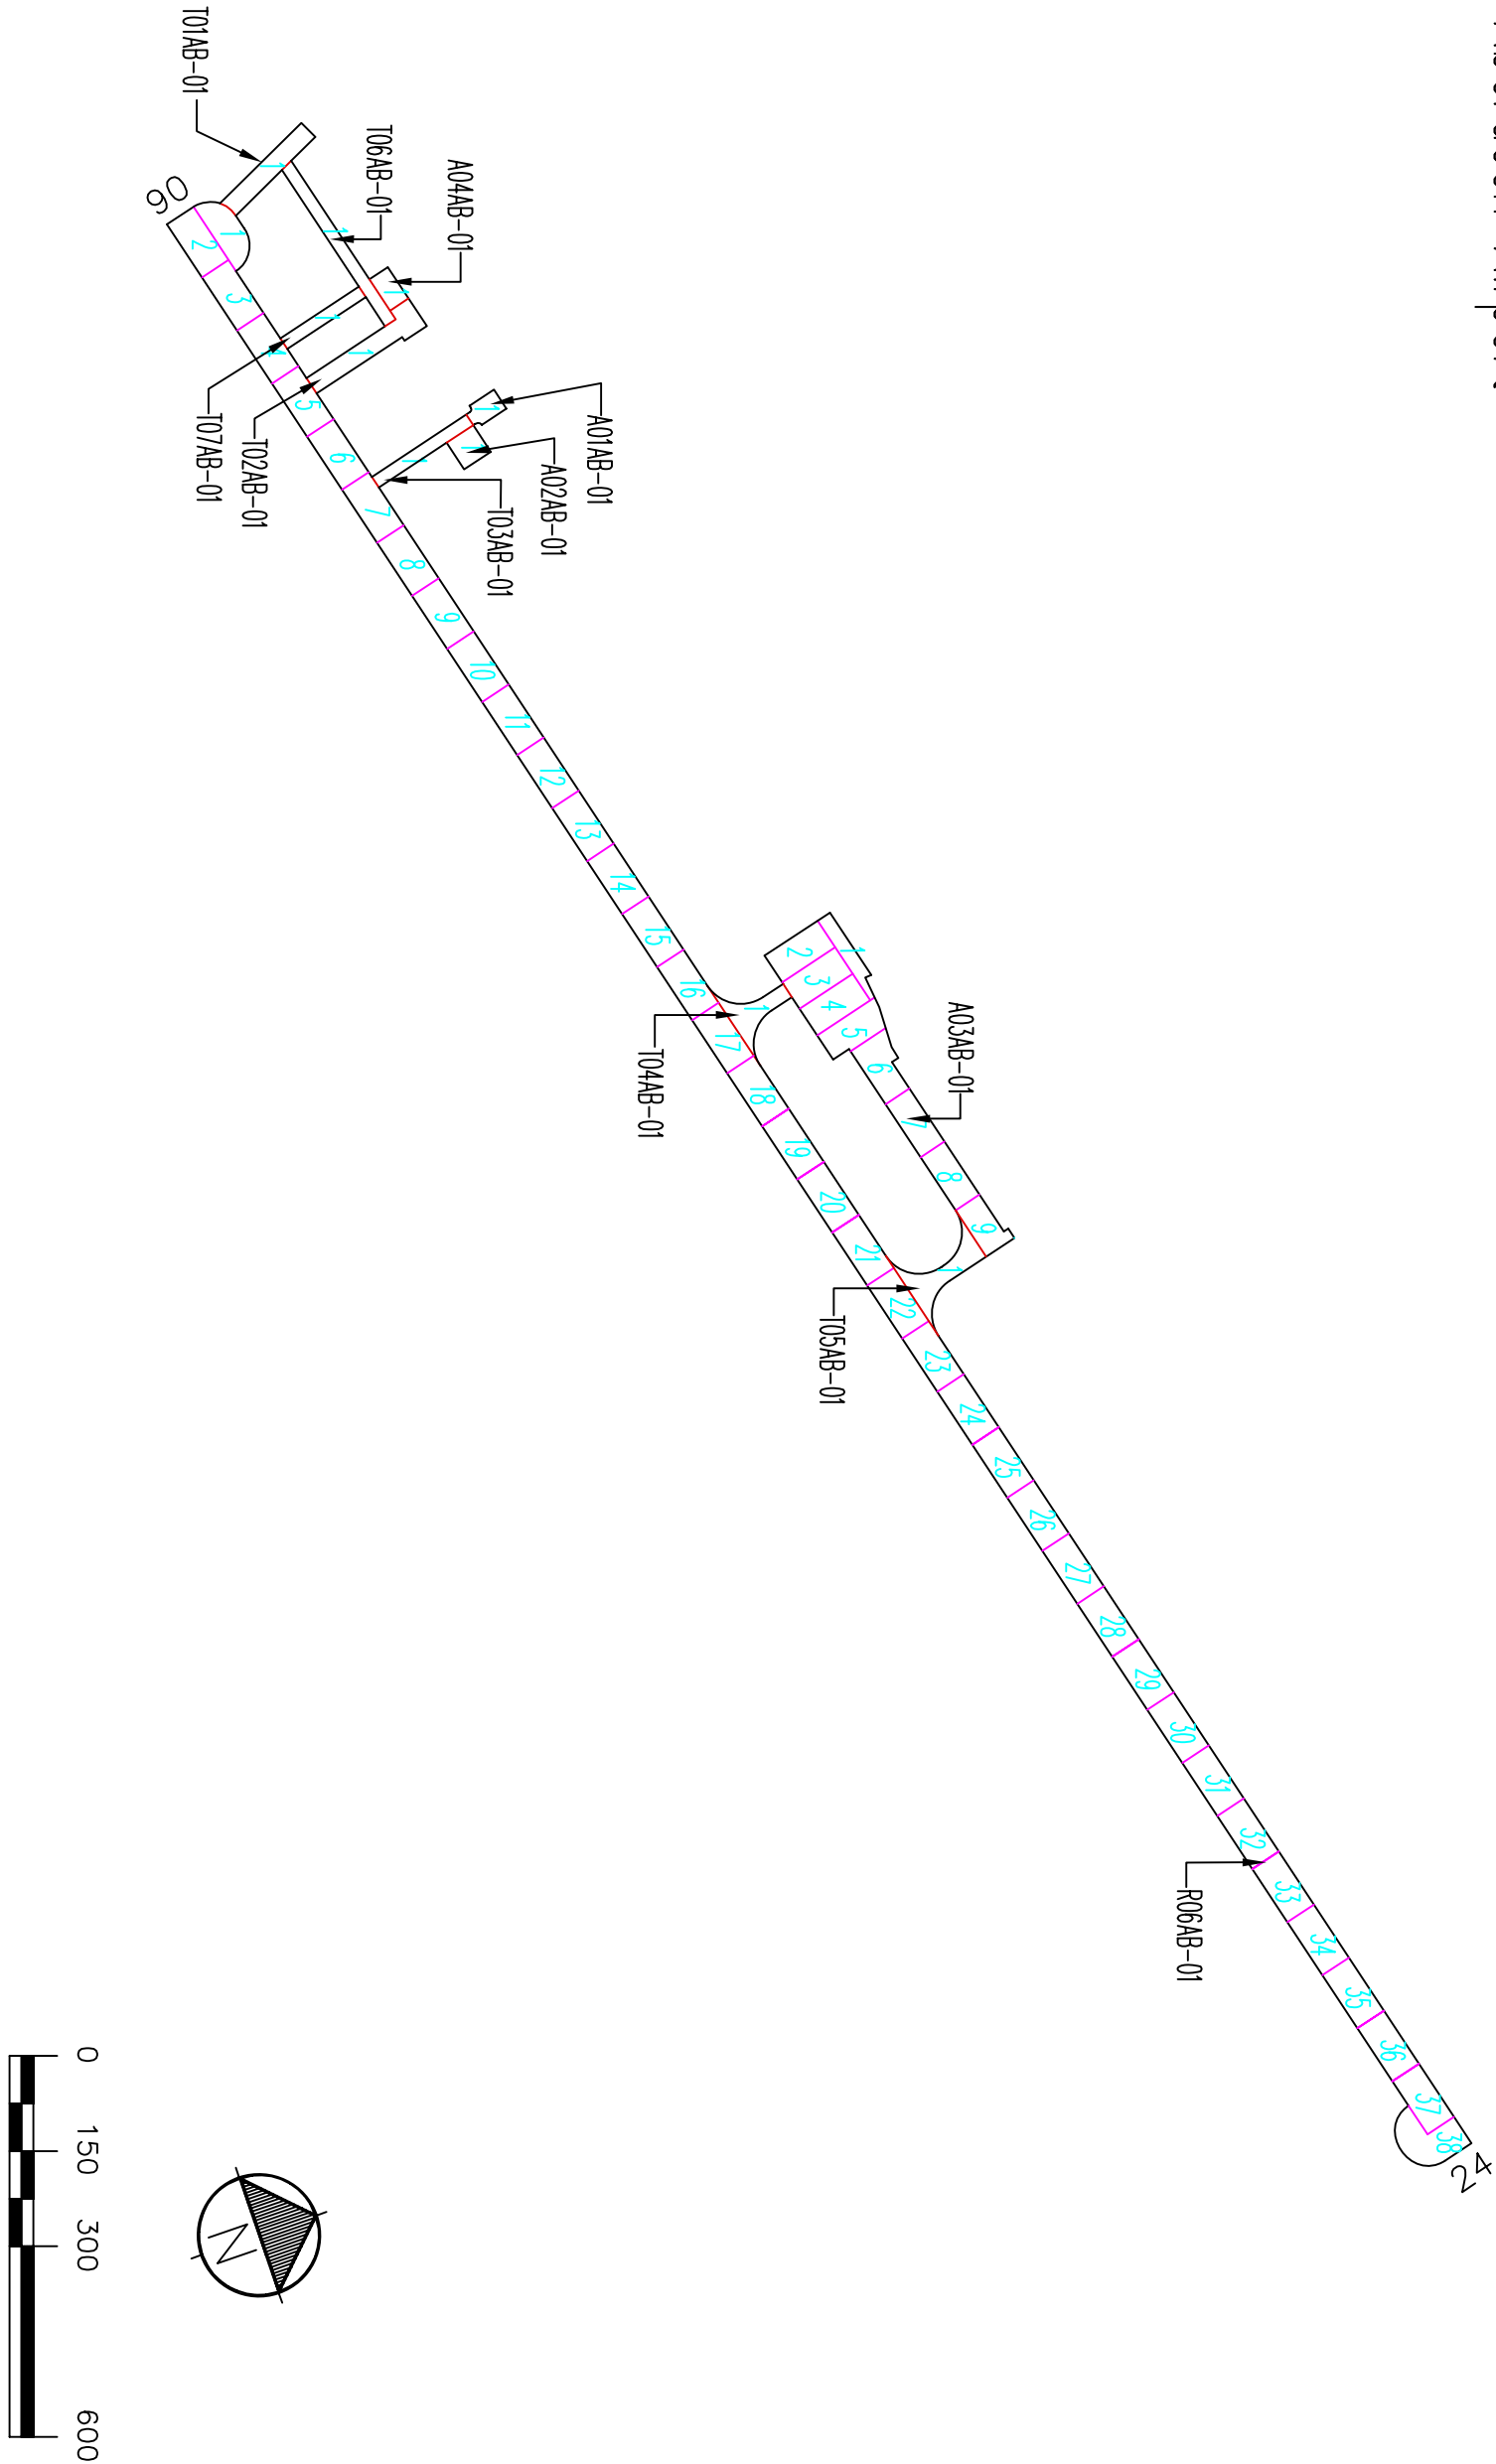
Figure AB-2. Pavement Branch, Section and Sample Unit Layout.
Aberdeen Airport

The pavements at your airport were divided into branches, sections and sample units in accordance with the methodology outlined in the current editions of FAA Advisory Circular AC:150/5380-6, *Guidelines and Procedures for Maintenance of Airport Pavements* and ASTM D5430, *Standard Test Method for Airport Condition Index Surveys*. The branches, sections and sample units established at your airport are shown in Figure AB-2. A Branch Condition Report showing all branches, their associated areas, and area-weighted average condition is provided in Appendix 2. Additionally, the Appendix 2 Section Condition Report provides information that the Micro PAVER pavement management software uses to define each branch and section.

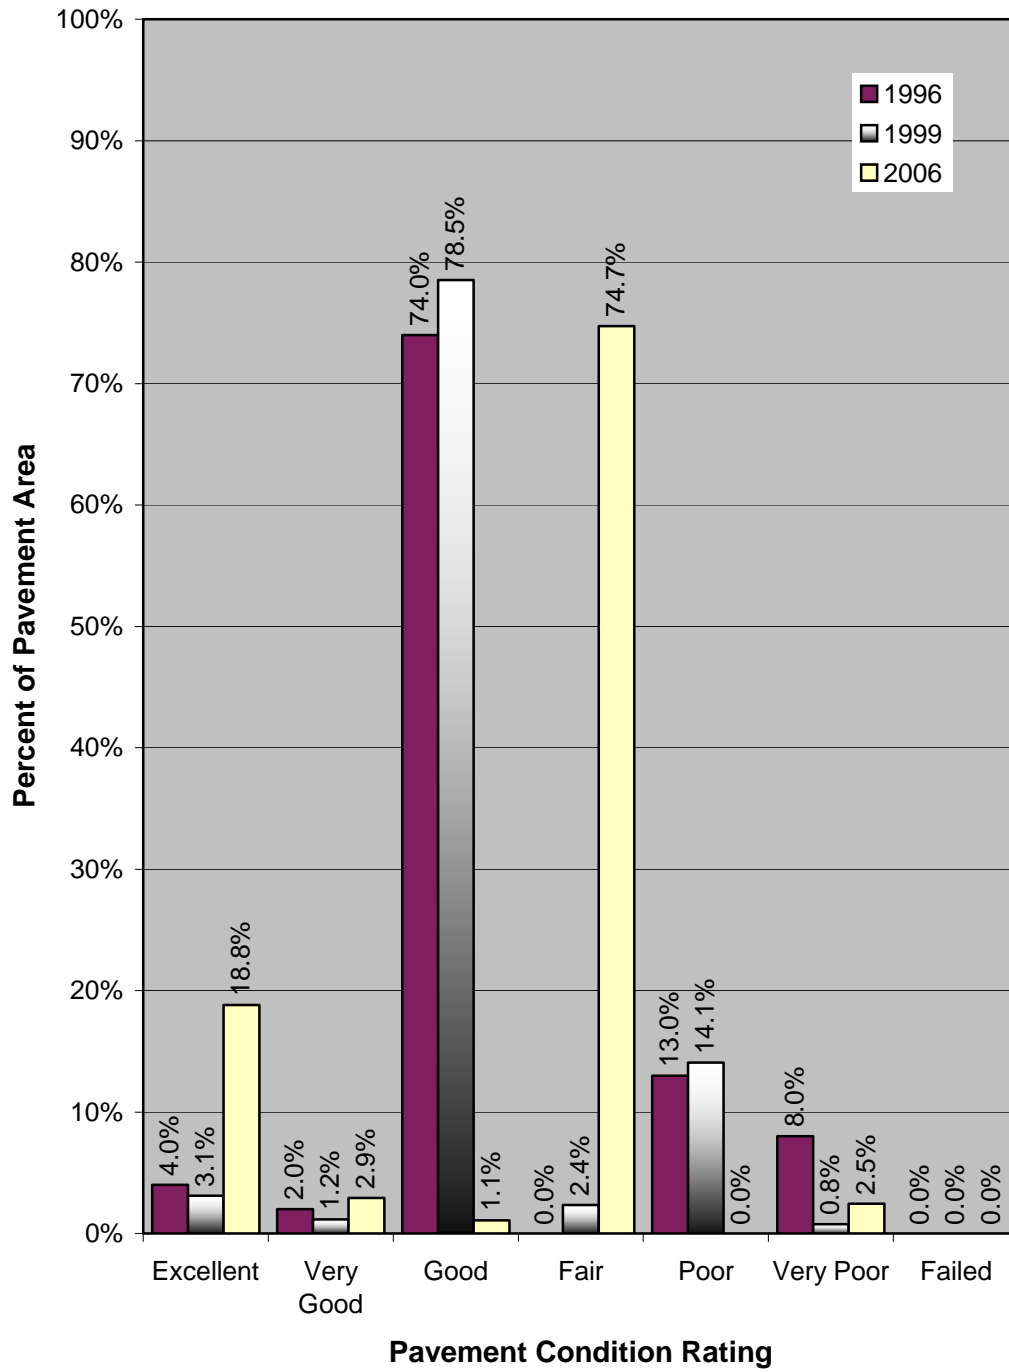
**Figure AB-4. Distribution of Pavement Condition
Aberdeen Airport**

Section PCIs at the airport range from a low of 24 (a PCR of "Very Poor") to a high of 100 (a PCR of "Excellent"). The area-weighted average PCI for all airport pavements is 56, corresponding to an overall PCR of "Good". Figure AB-4 shows how much pavement area is associated with each Pavement Condition Rating category and also shows pavement condition distribution from the inspections conducted in 1996 and 1999. A graphical representation of the projected PCRs presented in Table AB-2 is shown in Figure AB-5.
